SMOKE TESTING OBSERVATION SUMMARY

Western Run Pilot Project - Baltimore Maryland

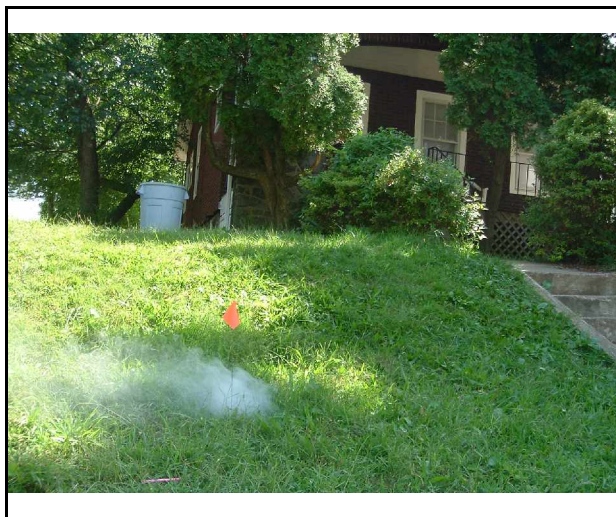
Photo No: 21

Unique Test ID	96	Date:	9/1/2004	MeterBasin:	01_WR19
Observer ID:	A	Crew:	T-1	Dye Test Recommended:	N
Defect No:	1	Setup No:	4	Priority CCTV:

House Number	Street Prefix:	Street Name:	Street Type:
3505		Devonshire	DR

Source Type:	04= Cleanout	Location:	7=Yard-Front	Severity:
Sector:	2=Private	Drainage Area:	0

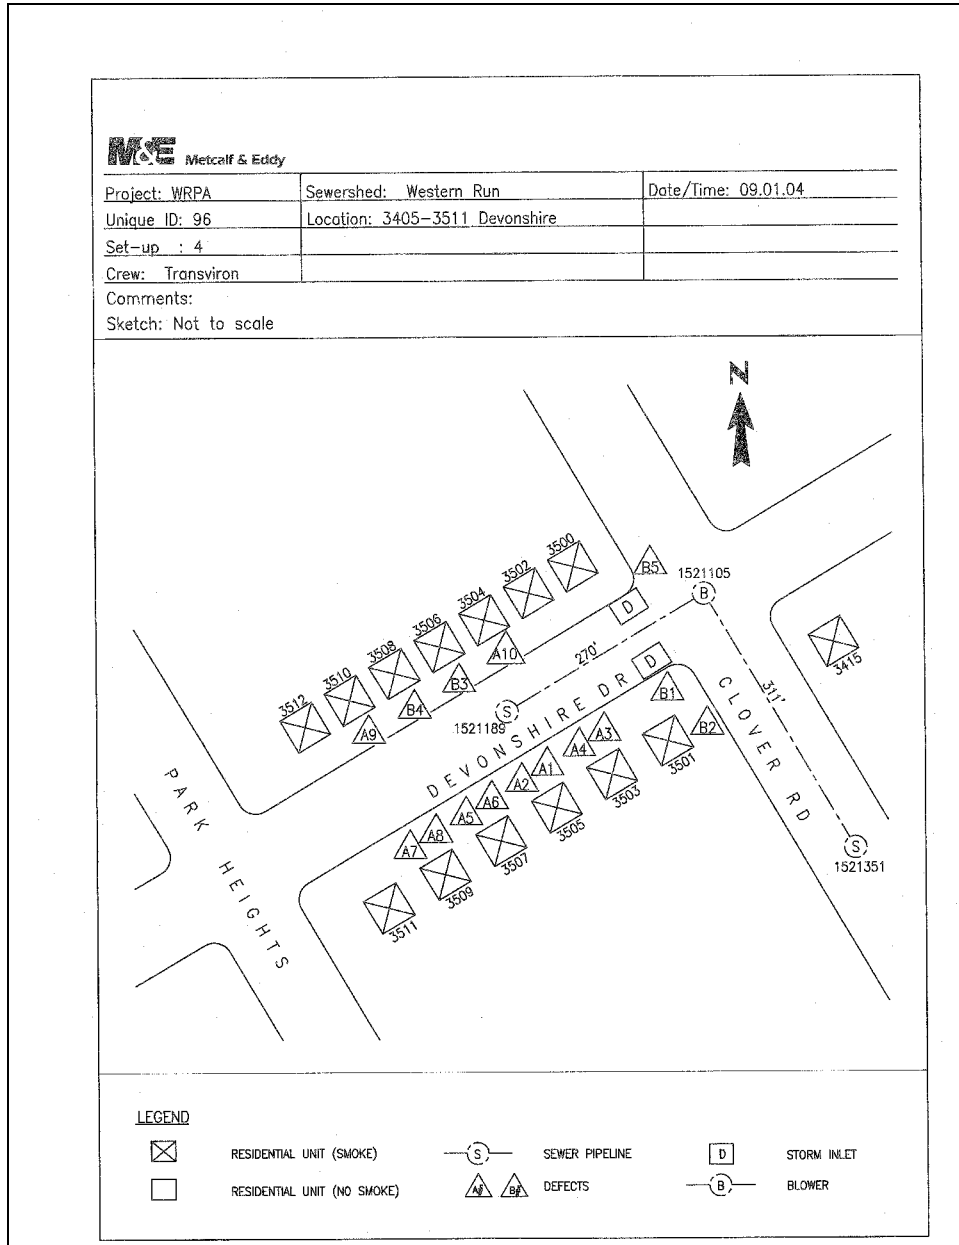
Sketch No: 96

NOTE: Sanitary sewer alignments and connectivity in the Western Run GIS have been revised following smoke testing to reflect updated information from various sources and may no longer match the field sketches shown.

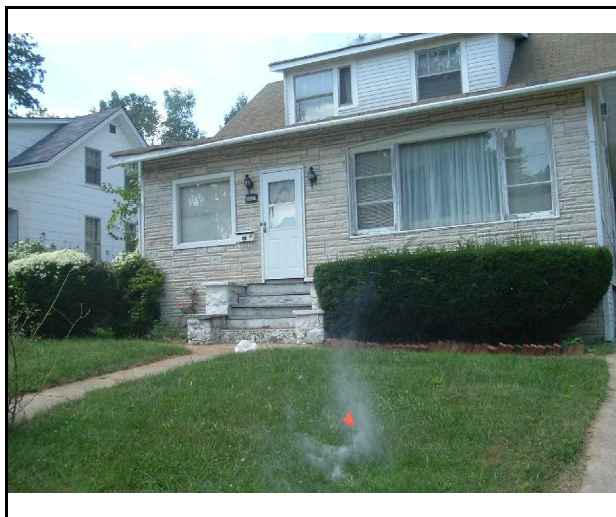
Photo No: 29

Unique Test ID	96	Date:	9/1/2004	MeterBasin:	01_WR19
Observer ID:	A	Crew:	T-1	Dye Test Recommended:	N
Defect No:	10	Setup No:	4	Priority CCTV:

House Number	3504	Street Prefix:		Street Name:	Devonshire	Street Type:	DR
Source Type:	04= Cleanout	Location:	7=Yard-Front	Severity:			
Sector:	2=Private	Drainage Area:	25				
Comments:

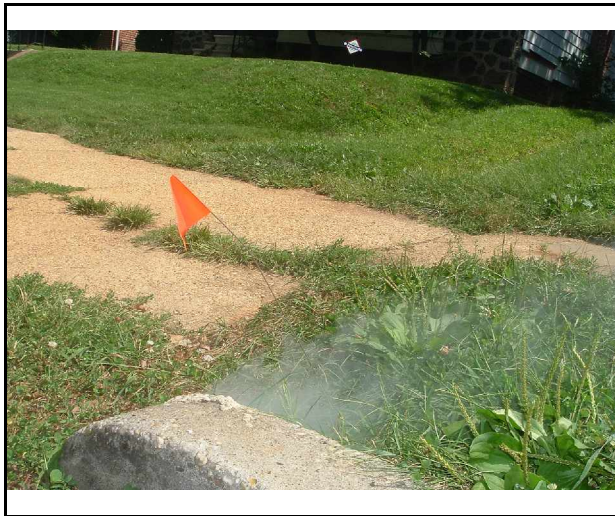
Photo No: 22

Unique Test ID	96	Date:	9/1/2004	MeterBasin:	01_WR19
Observer ID:	A	Crew:	T-1	Dye Test Recommended:	N
Defect No:	2	Setup No:	4	Priority CCTV:

House Number	Street Prefix:	Street Name:	Street Type:
3505		Devonshire	DR

Source Type:	02= Service Line	Location:	5=Sidewalk	Severity:
Sector:	1=Public	Drainage Area:	50

Comments: hole in ground -

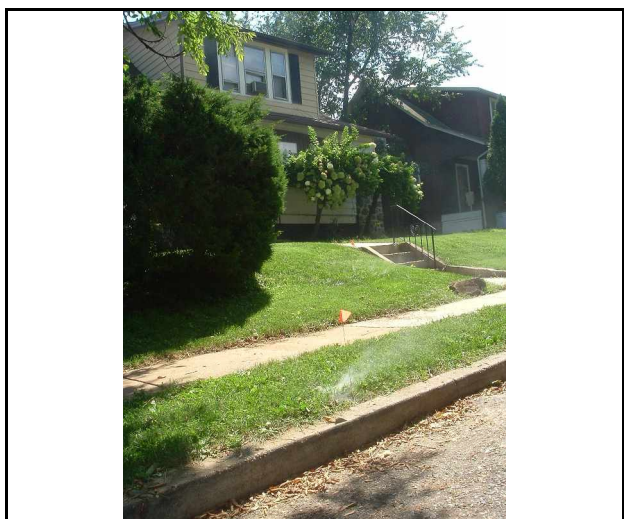
Photo No: 23

Unique Test ID	96	Date:	9/1/2004	MeterBasin:	01_WR19
Observer ID:	A	Crew:	T-1	Dye Test Recommended:	N
Defect No:	3	Setup No:	4	Priority CCTV:

House Number	Street Prefix:	Street Name:	Street Type:
3503		Devonshire	DR

Source Type:	02= Service Line	Location:	5=Sidewalk	Severity:
Sector:	1=Public	Drainage Area:	25

Comments: hole in ground on street side of sidewalk

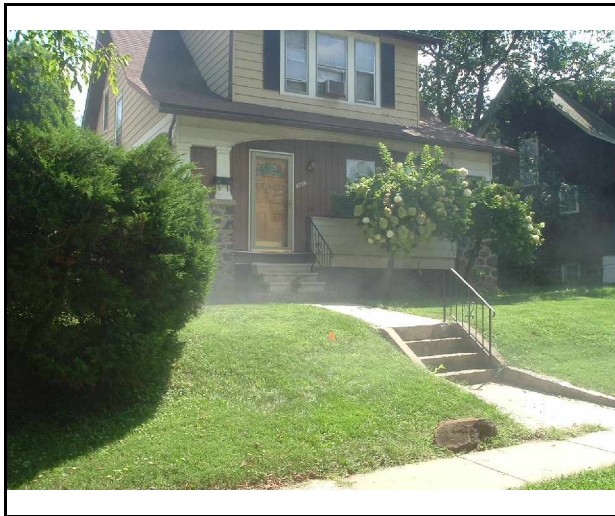
Photo No: 24

Unique Test ID	96	Date:	9/1/2004	MeterBasin:	01_WR19
Observer ID:	A	Crew:	T-1	Dye Test Recommended:	N
Defect No:	4	Setup No:	4	Priority CCTV:

House Number	Street Prefix:	Street Name:	Street Type:
3503		Devonshire	DR

Source Type:	04= Cleanout	Location:	7=Yard-Front	Severity:
Sector:	2=Private	Drainage Area:	25

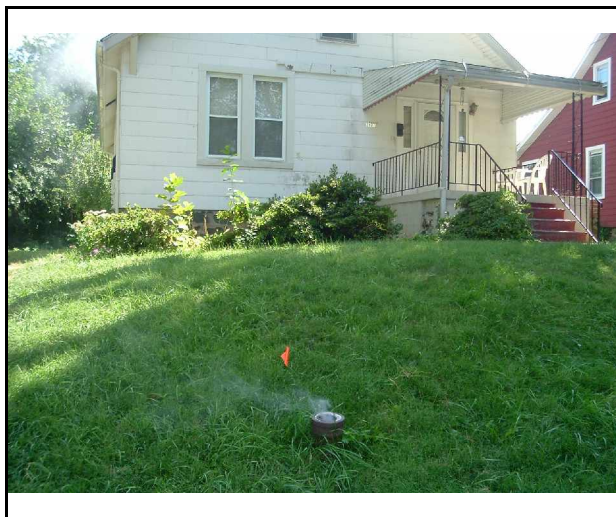
Photo No: 25

Unique Test ID	96	Date:	9/1/2004	MeterBasin:	01_WR19
Observer ID:	A	Crew:	T-1	Dye Test Recommended:	N
Defect No:	5	Setup No:	4	Priority CCTV:

House Number	Street Prefix:	Street Name:	Street Type:
3507		Devonshire	DR

Source Type:	04= Cleanout	Location:	7=Yard-Front	Severity:
Sector:	2=Private	Drainage Area:	0

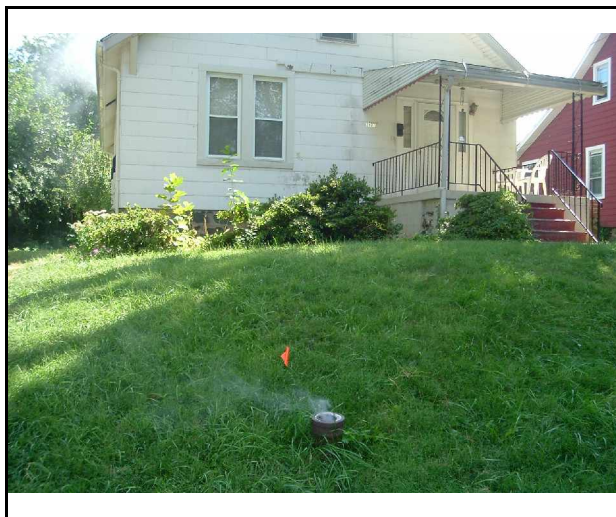
Photo No: 25

Unique Test ID	96	Date:	9/1/2004	MeterBasin:	01_WR19
Observer ID:	A	Crew:	T-1	Dye Test Recommended:	N
Defect No:	6	Setup No:	4	Priority CCTV:

House Number	Street Prefix:	Street Name:	Street Type:
3507		Devonshire	DR

Source Type:	02= Service Line	Location:	5=Sidewalk	Severity:
Sector:	1=Public	Drainage Area:	25

Comments: looks like service line smoking from water meter

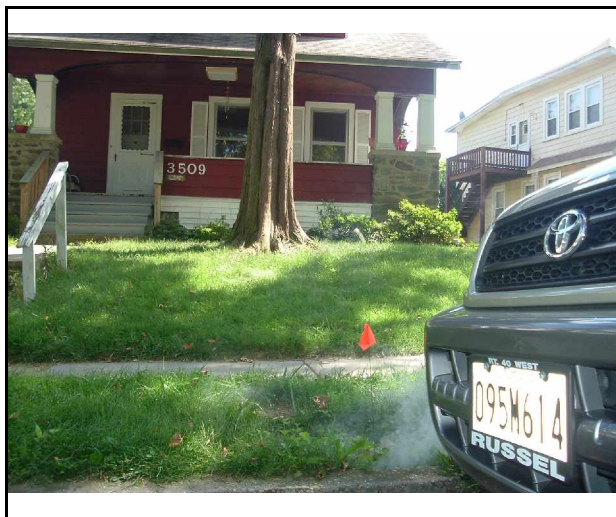
Photo No: 27

Unique Test ID	96	Date:	9/1/2004	MeterBasin:	01_WR19
Observer ID:	A	Crew:	T-1	Dye Test Recommended:	N
Defect No:	7	Setup No:	4	Priority CCTV:

House Number	Street Prefix:	Street Name:	Street Type:
3509		Devonshire	DR

Source Type:	04= Cleanout	Location:	7=Yard-Front	Severity:
Sector:	2=Private	Drainage Area:	25

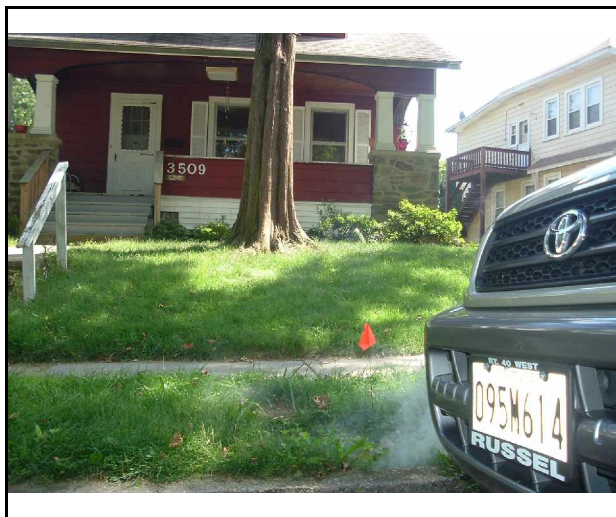
Photo No: 27

Unique Test ID	96	Date:	9/1/2004	MeterBasin:	01_WR19
Observer ID:	A	Crew:	T-1	Dye Test Recommended:	N
Defect No:	8	Setup No:	4	Priority CCTV:

House Number	Street Prefix:	Street Name:	Street Type:
3509		Devonshire	DR

Source Type:	02= Service Line	Location:	14=Other	Severity:
Sector:	1=Public	Drainage Area:	50

Comments: water meter and hole in ground

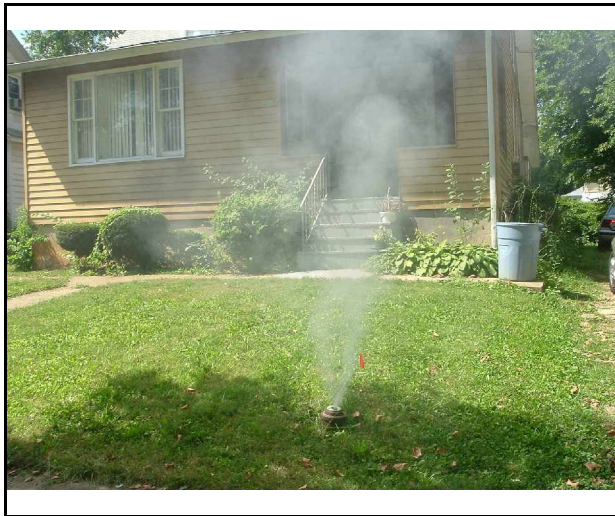
Photo No: 28

Unique Test ID	96	Date:	9/1/2004	MeterBasin:	01_WR19
Observer ID:	A	Crew:	T-1	Dye Test Recommended:	N
Defect No:	9	Setup No:	4	Priority CCTV:

House Number	3510	Street Prefix:		Street Name:	Devonshire	Street Type:	DR
Source Type:	04= Cleanout	Location:	7=Yard-Front	Severity:			
Sector:	2=Private	Drainage Area:	25				
Comments:

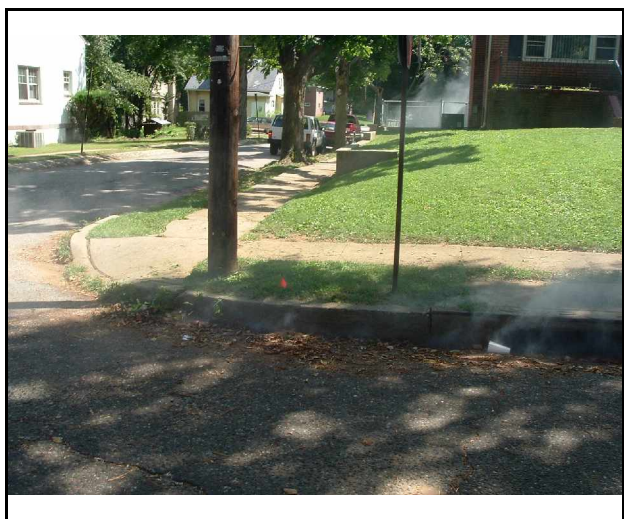
Photo No: 21

Unique Test ID	96	Date:	9/1/2004	MeterBasin:	01_WR19
Observer ID:	B	Crew:	T-1	Dye Test Recommended:	Y
Defect No:	1	Setup No:	4	Priority CCTV:

House Number	Street Prefix:	Street Name:	Street Type:
3501		Devonshire	DR
Source Type:	14= Catch Basin	Location:	5=Sidewalk
Sector:	1=Public	Drainage Area:	1200
Comments:	corner of streets

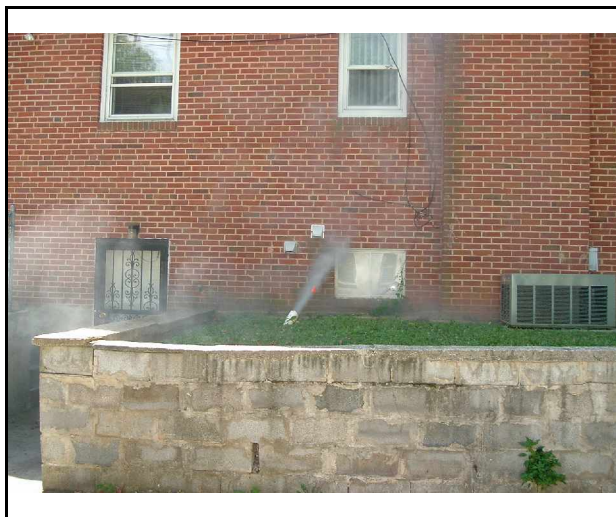
Photo No: 22

Unique Test ID	96	Date:	9/1/2004	MeterBasin:	01_WR19
Observer ID:	B	Crew:	T-1	Dye Test Recommended:	N
Defect No:	2	Setup No:	4	Priority CCTV:

House Number	Street Prefix:	Street Name:	Street Type:
3501		Devonshire	DR

Source Type:	04= Cleanout	Location:	9=Yard-Side	Severity:
Sector:	2=Private	Drainage Area:	0

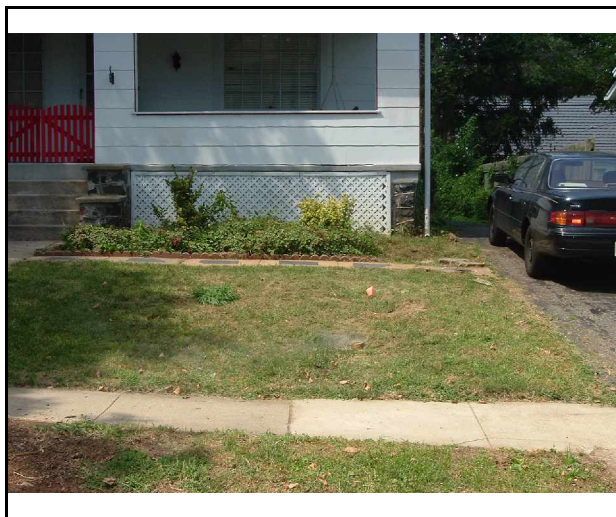
Photo No: 23

Unique Test ID	96	Date:	9/1/2004	MeterBasin:	01_WR19
Observer ID:	B	Crew:	T-1	Dye Test Recommended:	N
Defect No:	3	Setup No:	4	Priority CCTV:

House Number	Street Prefix:	Street Name:	Street Type:
3506		Devonshire	DR

Source Type:	04= Cleanout	Location:	7=Yard-Front	Severity:
Sector:	2=Private	Drainage Area:	0

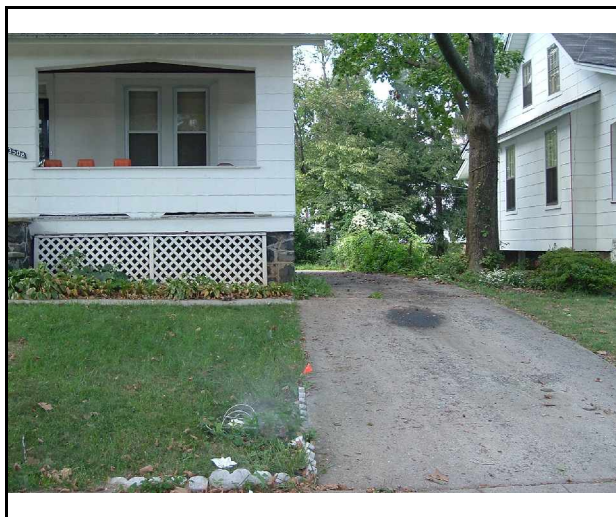
Photo No: 24

Unique Test ID	96	Date:	9/1/2004	MeterBasin:	01_WR19
Observer ID:	B	Crew:	T-1	Dye Test Recommended:	N
Defect No:	4	Setup No:	4	Priority CCTV:

House Number	Street Prefix:	Street Name:	Street Type:
3508		Devonshire	DR

Source Type:	02= Service Line	Location:	4=Driveway	Severity:
Sector:	2=Private	Drainage Area:	100

Comments: Crack in driveway

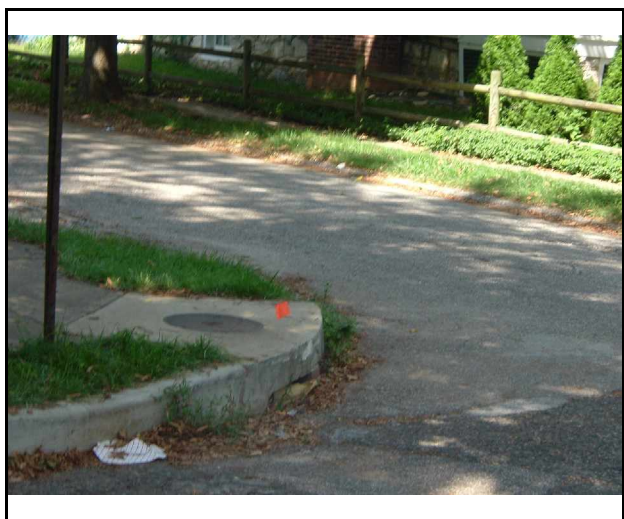
Photo No: 25

Unique Test ID	96	Date:	9/1/2004	MeterBasin:	01_WR19
Observer ID:	B	Crew:	T-1	Dye Test Recommended:	Y
Defect No:	5	Setup No:	4	Priority CCTV:

House Number	Street Prefix:	Street Name:	Street Type:
3500		Devonshire	DR
Source Type:	14= Catch Basin	Location:	6=Curb
Sector:	1=Public	Drainage Area:	1500
Comments:	corner of streets

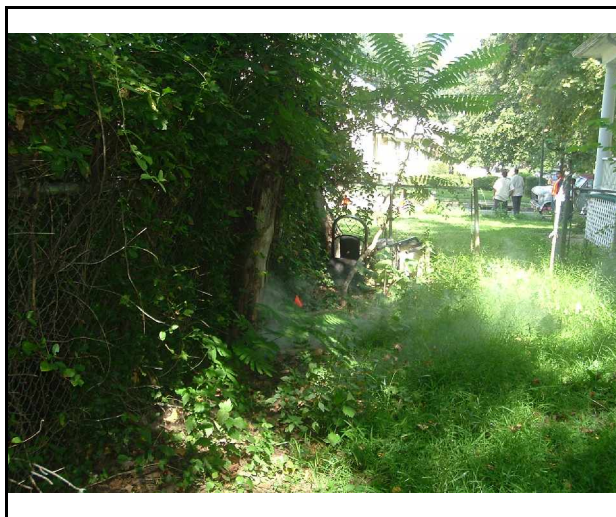
Unique Test ID	97	Date:	9/1/2004	MeterBasin:	01_WR23
Observer ID:	A	Crew:	T-1	Dye Test Recommended:	N
Defect No:	1	Setup No:	5	Priority CCTV:

House Number	Street Prefix:	Street Name:	Street Type:
6006		Clover	ROAD

Source Type:	01= Main Sewer	Location:	9=Yard-Side	Severity:
Sector:	2=Private	Drainage Area:	50

Comments: hole in ground rear of home

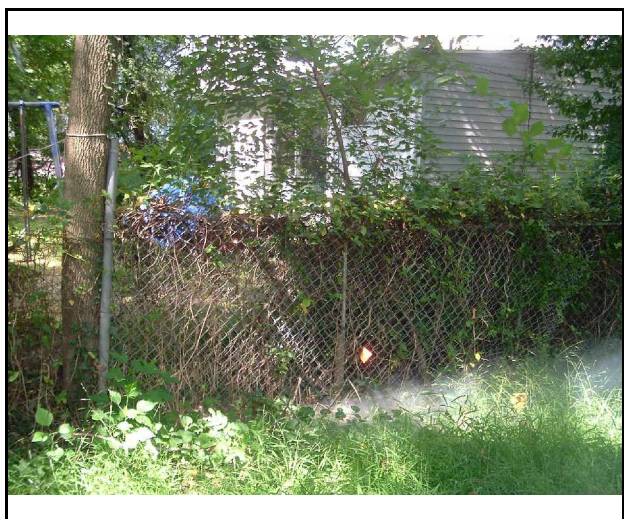
Unique Test ID	97	Date:	9/1/2004	MeterBasin:	01_WR23
Observer ID:	A	Crew:	T-1	Dye Test Recommended:	N
Defect No:	2	Setup No:	5	Priority CCTV:

Comments: rear of home

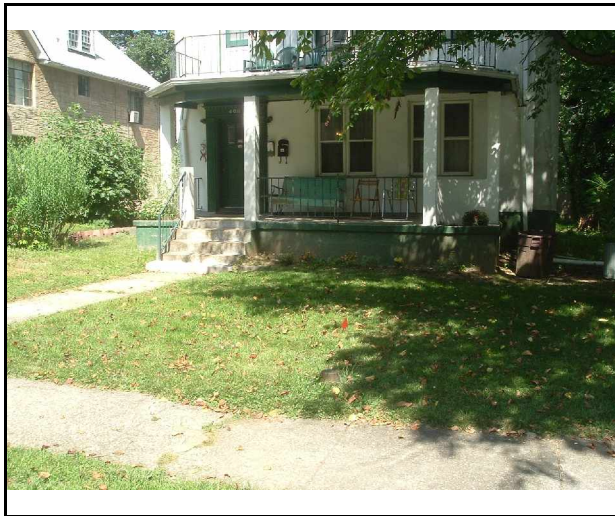
Unique Test ID	97	Date:	9/1/2004	MeterBasin:	01_WR23
Observer ID:	A	Crew:	T-1	Dye Test Recommended:	N
Defect No:	3	Setup No:	5	Priority CCTV:

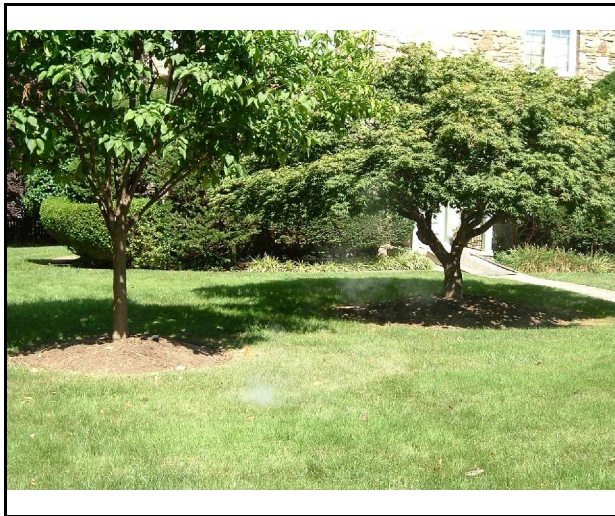
Unique Test ID	97	Date:	9/1/2004	MeterBasin:	01_WR23
Observer ID:	B	Crew:	T-1	Dye Test Recommended:	N
Defect No:	1	Setup No:	5	Priority CCTV:

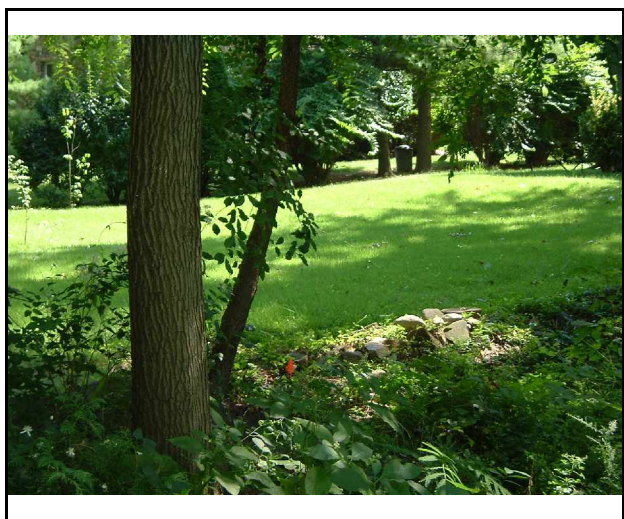
Unique Test ID	97	Date:	9/1/2004	MeterBasin:	01_WR05
Observer ID:	B	Crew:	T-1	Dye Test Recommended:	N
Defect No:	2	Setup No:	5	Priority CCTV:

Comments: holes in ground
